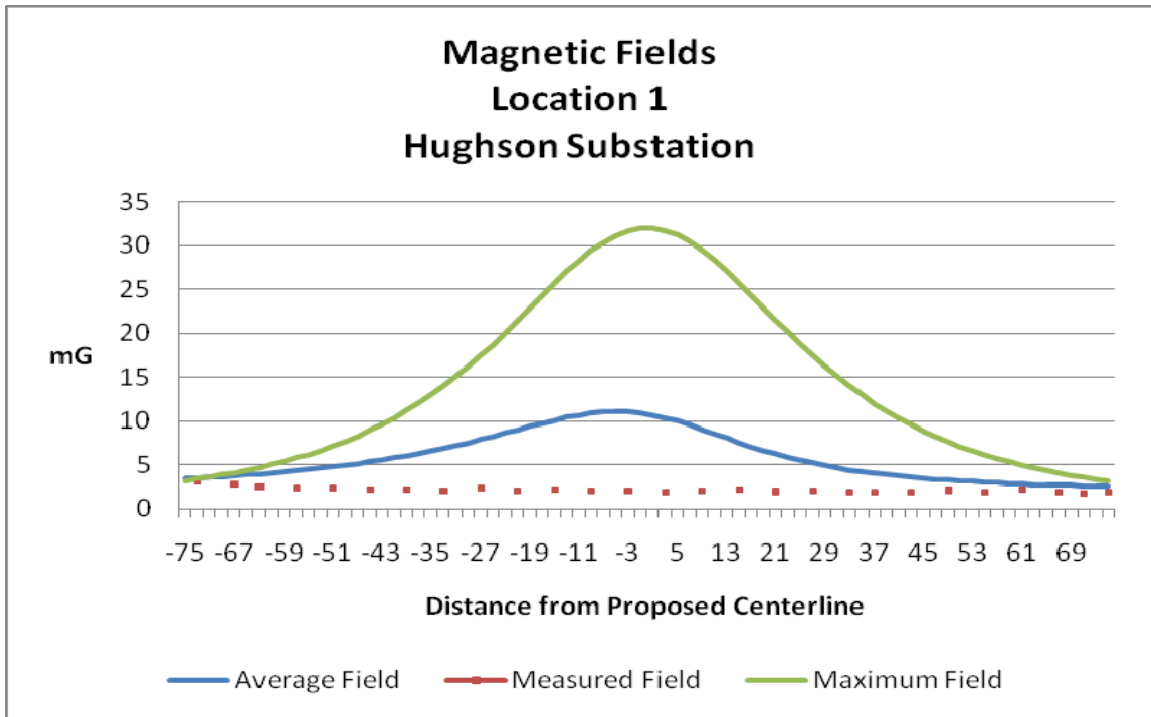
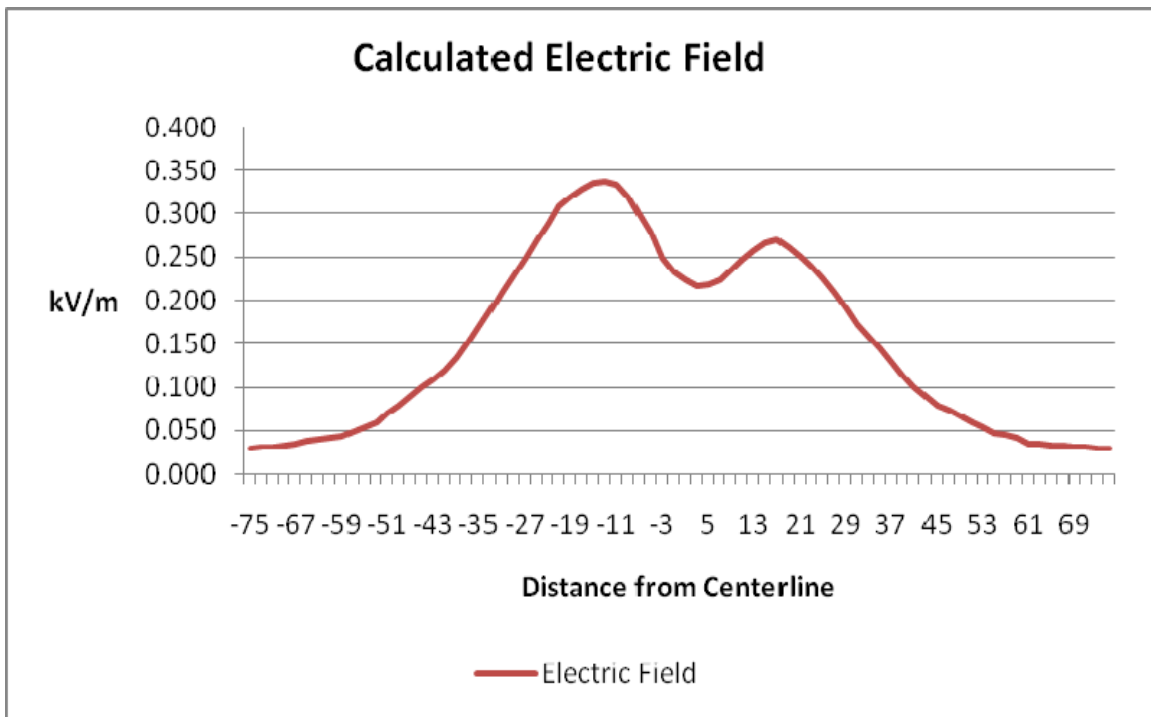
Measurements were taken along Geer Road in front of the existing Hughson Substation. Background magnetic fields from existing energized lines and substation equipment to the east results in slightly higher levels.

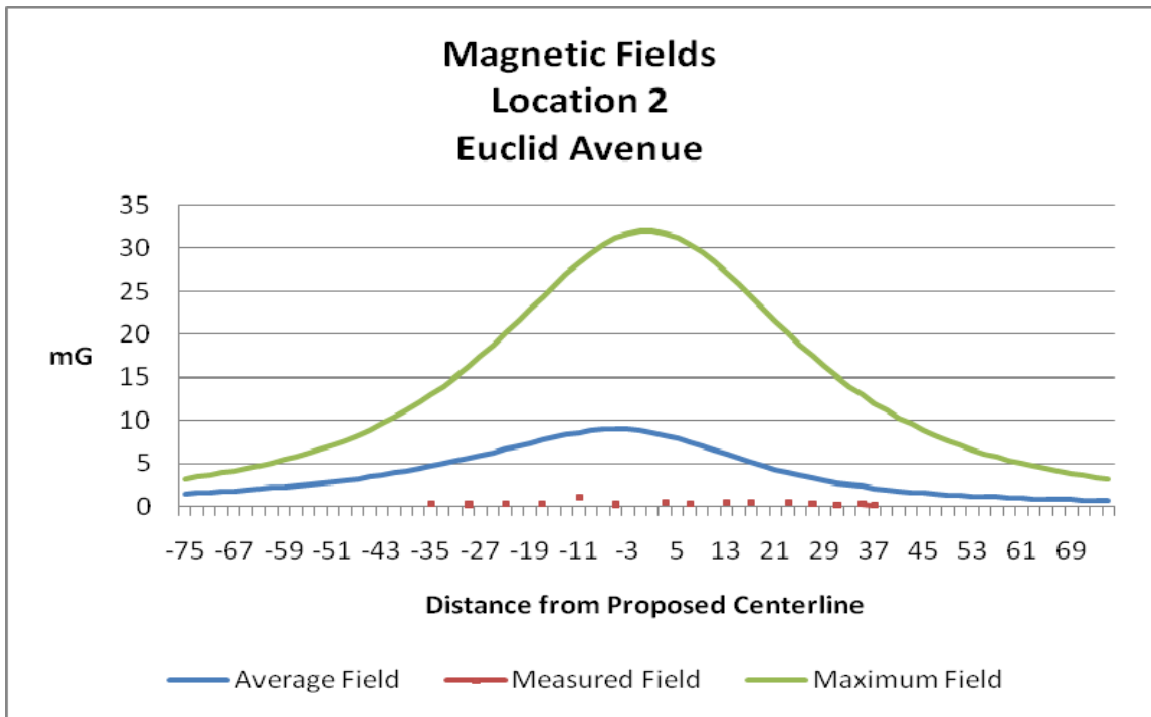
Measurements were taken along Euclid Avenue south of the East Whitmore Avenue. Background levels are considered low.

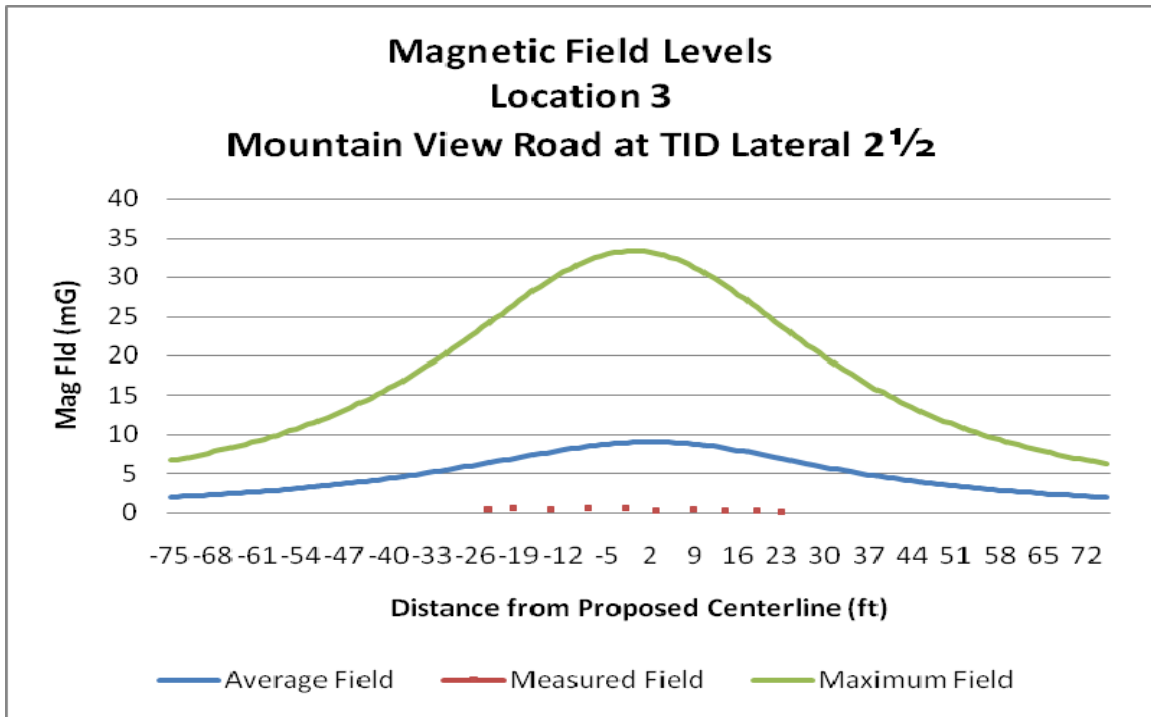
Measurements were taken across Mountain View Road near the TID Lateral 2½. Background levels are considered low.

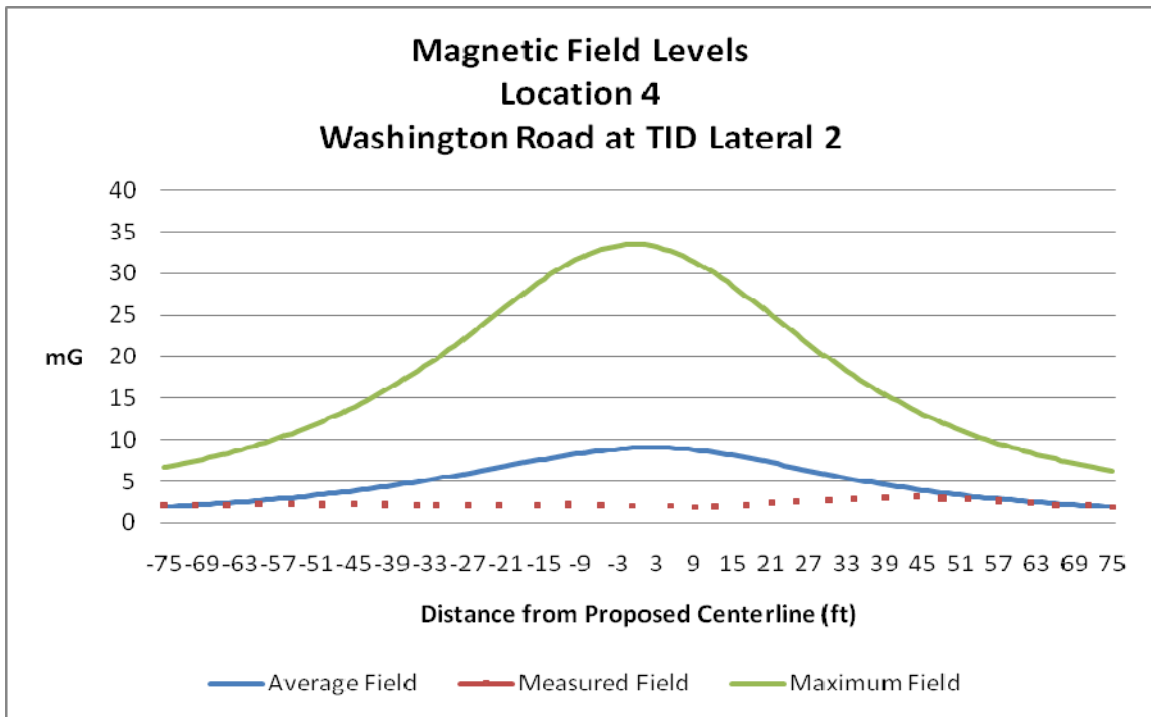
Measurements were taken across Washington Road near the TID Lateral 2. Background levels are somewhat elevated due to the proximity of an existing 69 kV line that runs along the canal right-of-way. This 69-kV line would be co-located on the 115-kV transmission poles.

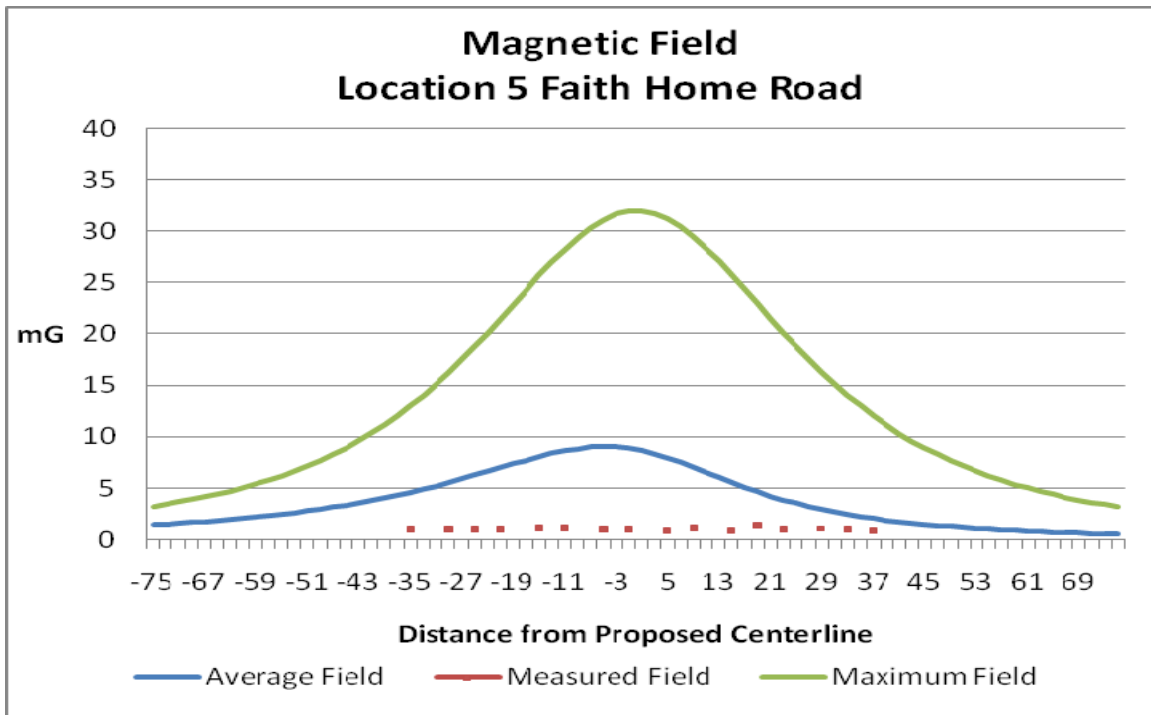
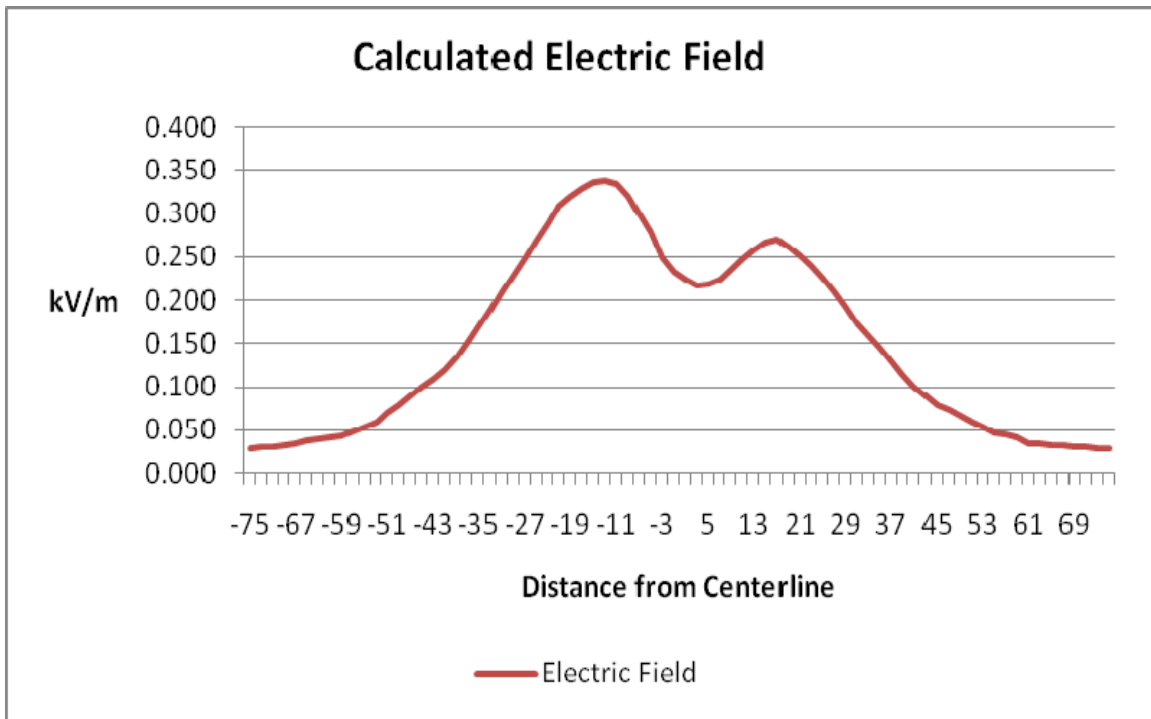
Measurements were taken along Faith Home Road south of the TID Lateral 2. Background levels are considered low.

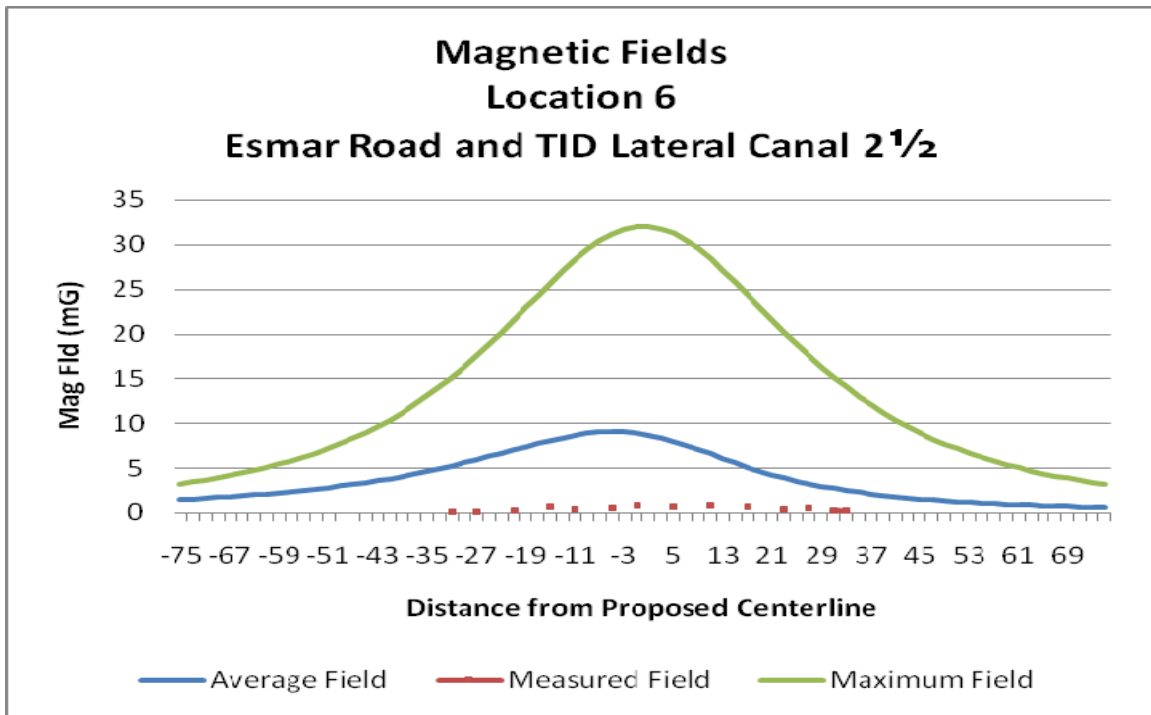
Measurements were taken across Esmar Road near the TID Lateral 2½ Canal. Background levels are considered low.

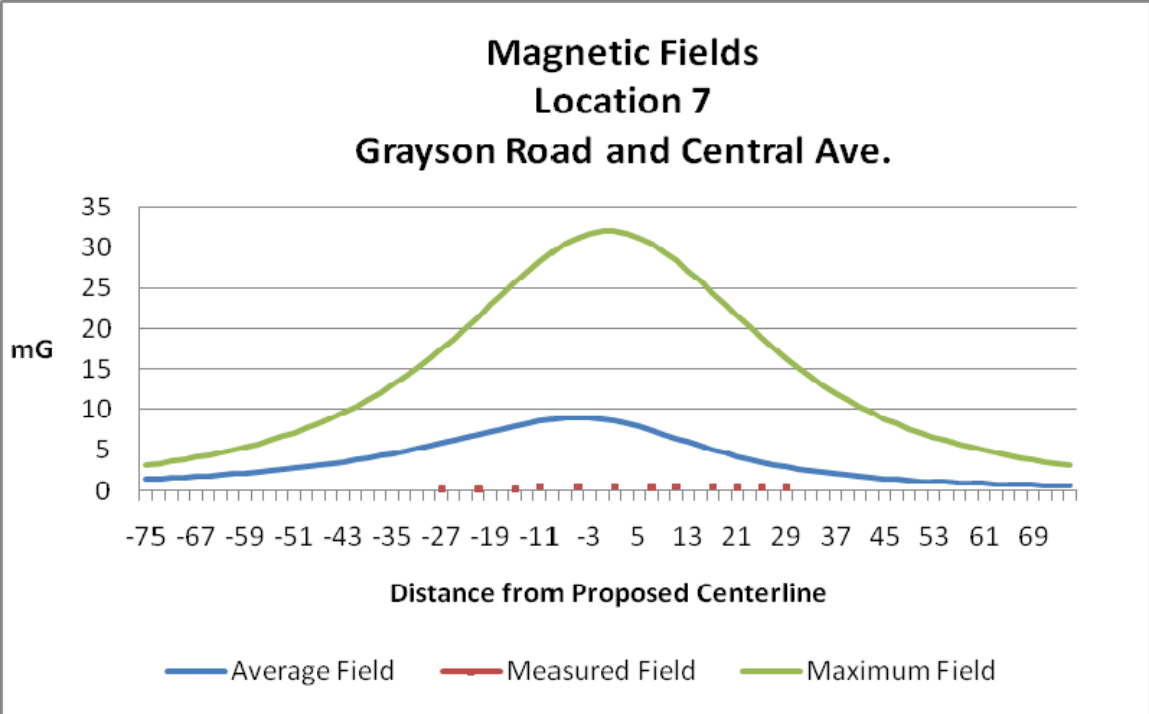
Measurements were taken across Grayson Road near the Central Ave. Background levels are considered low.

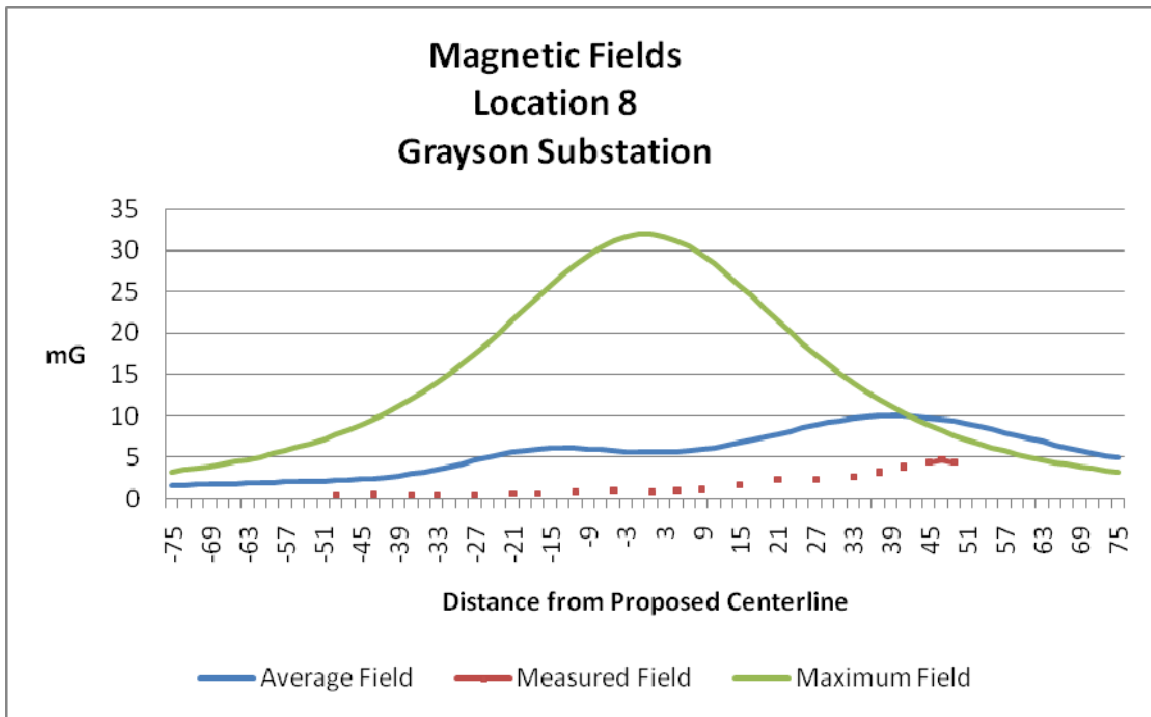
Measurements were taken along the proposed Grayson Substation property perpendicular to Grayson Road. A 69-kV Transmission Line would be located along the south side of Grayson Road, which has been included in the calculations. An existing 12-kV distribution line is the source of the increase in field levels approximately 45 feet to the right of the proposed centerline. This distribution line would be relocated to the 115-kV transmission line.

The results of the measurements are well within the anticipated range. Levels are at background levels at or below 0.2 milligauss in most cases. Measurements taken near the energized conductors at Location 8 (Grayson Substation), Location 1 (Hughson Substation), and Location 4 (Along TID Lateral 2½) were somewhat higher as expected due to the presence of existing energized transmission and distribution lines. Sufficient information has been presented to allow the taking of post-construction measurements for comparison with the calculated values.
